CLIMATE CHANGE –Transboundary Maritsa River Basin Case /GENEVA –UNECE Meeting 14-15 Feb 2019

Dursun Yıldız
Director
Hydropolitics Academy

Maritsa River Basin

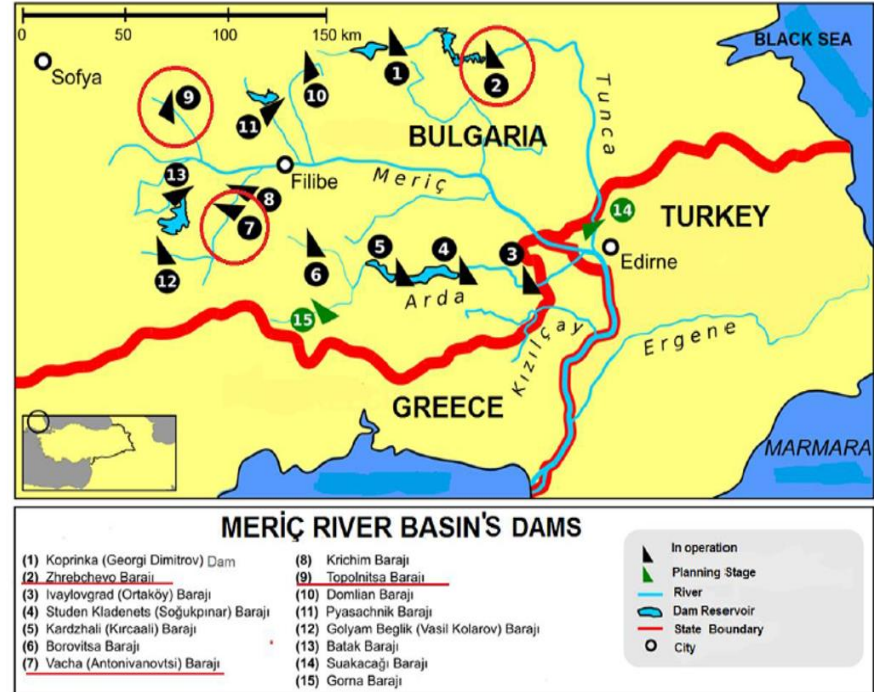
Dams in the Maritza Basin

- Throughout the Maritsa catchment area a significant number of reservoirs and weirs have been constructed for irrigation and hydroelectricity production purposes.

Meriç: 7 Dams + 9 Small Dams
Tunca: 4 Dams
Arda: 4 Dams

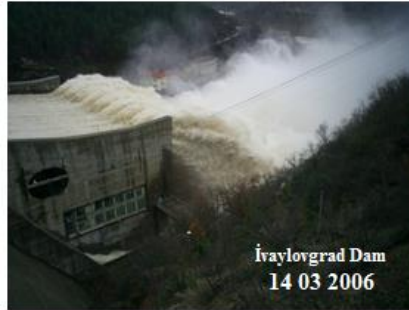
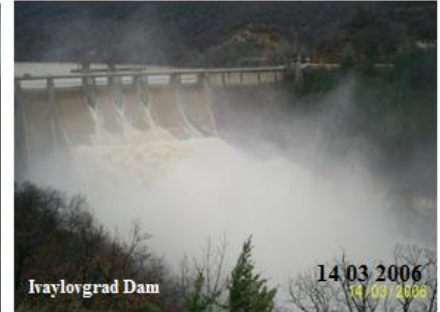
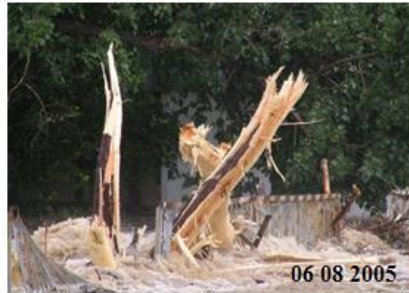
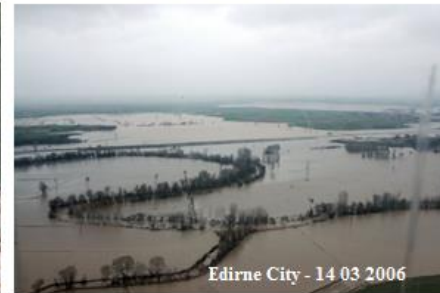
Flood discharge measured at Edirne Flow Measurement Station

- Floods in the Maritsa River over the last 12 years have caused significant damages.
- Total economic loss calculated at € more that 300 million Euro
- Extreme precipitation, snowmelt and water released from Bulgarian dams are the most frequent causes of flooding in the downstream city of Edirne.

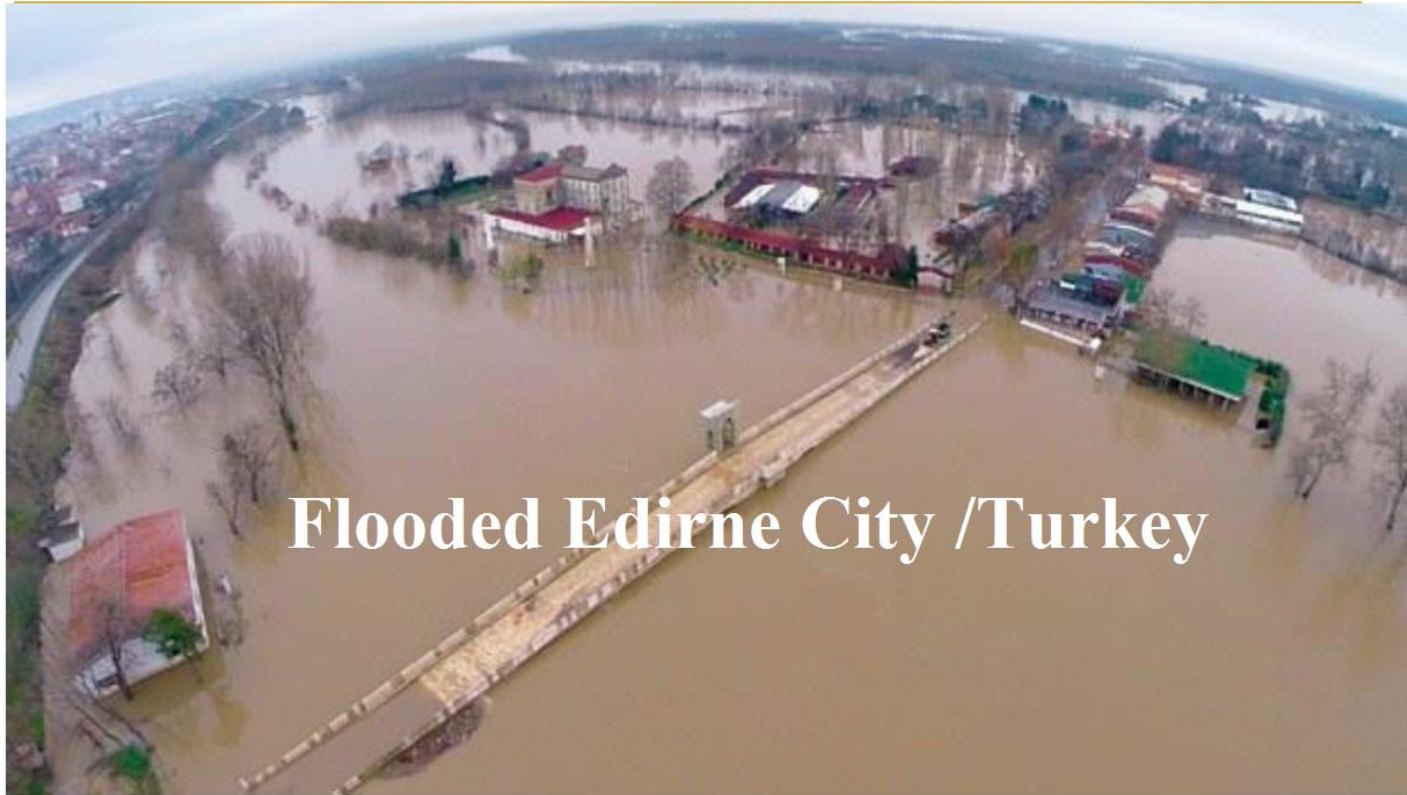
Flooded Edirne City /Turkey

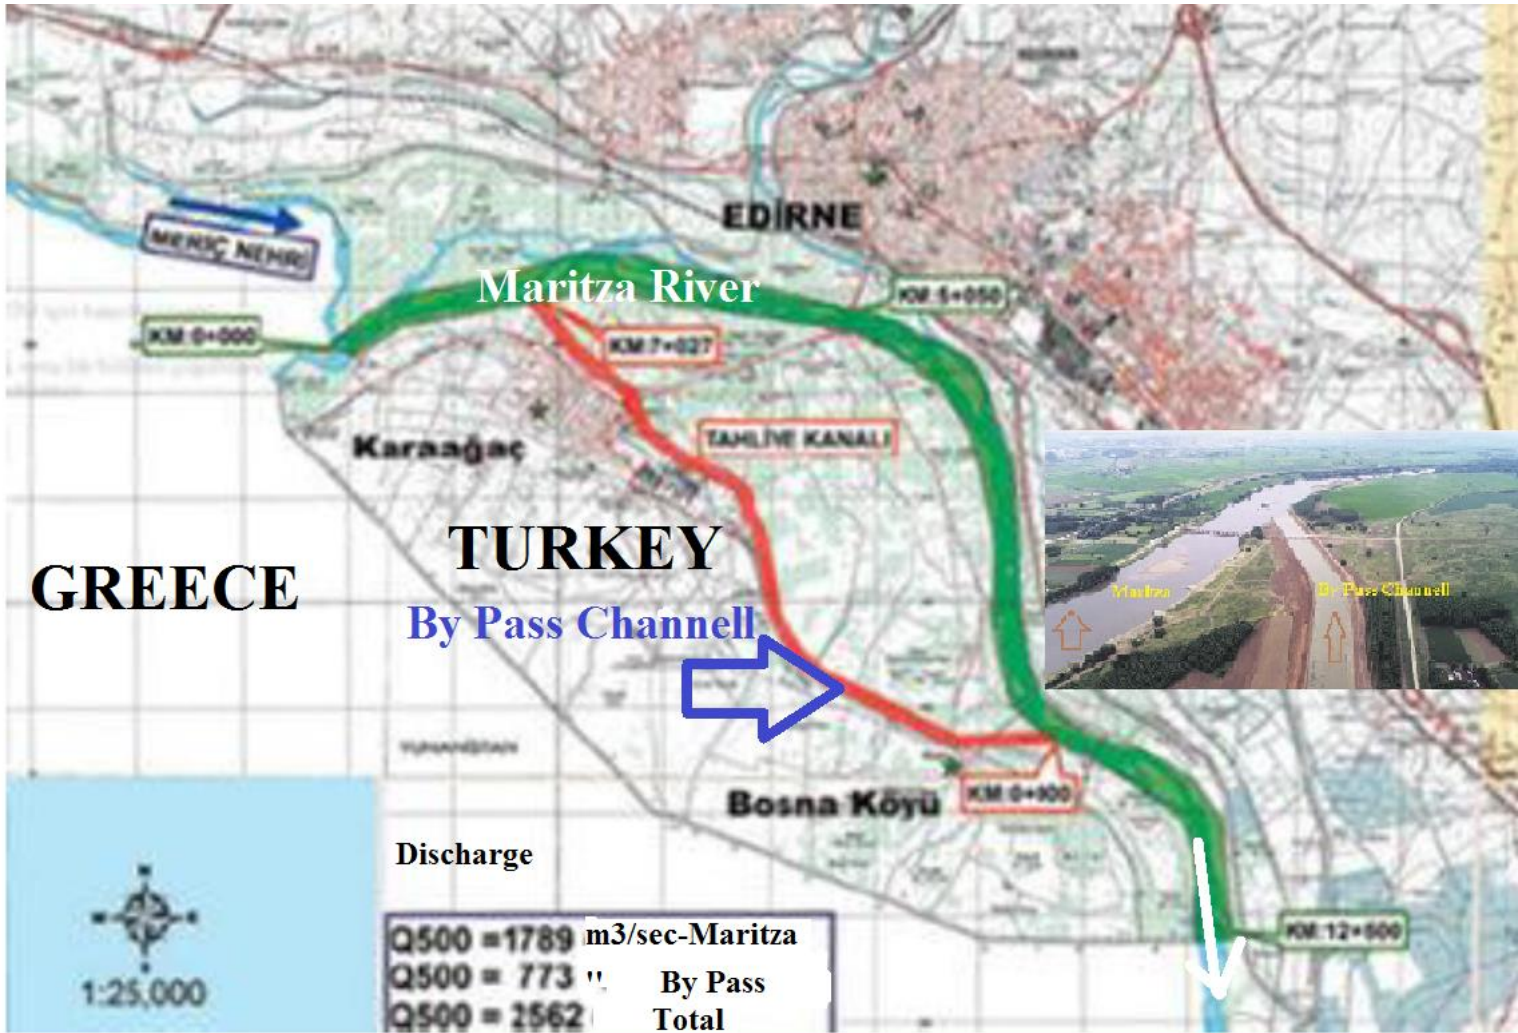
BY PASS CHANELL SOLUTION !!!!

- Flood **protection measures** in Turkey have become an urgent matter and Turkey has decided to take its own measures
 - Turkey built a by pass channell to protect Edirne City and agricultural lands
-

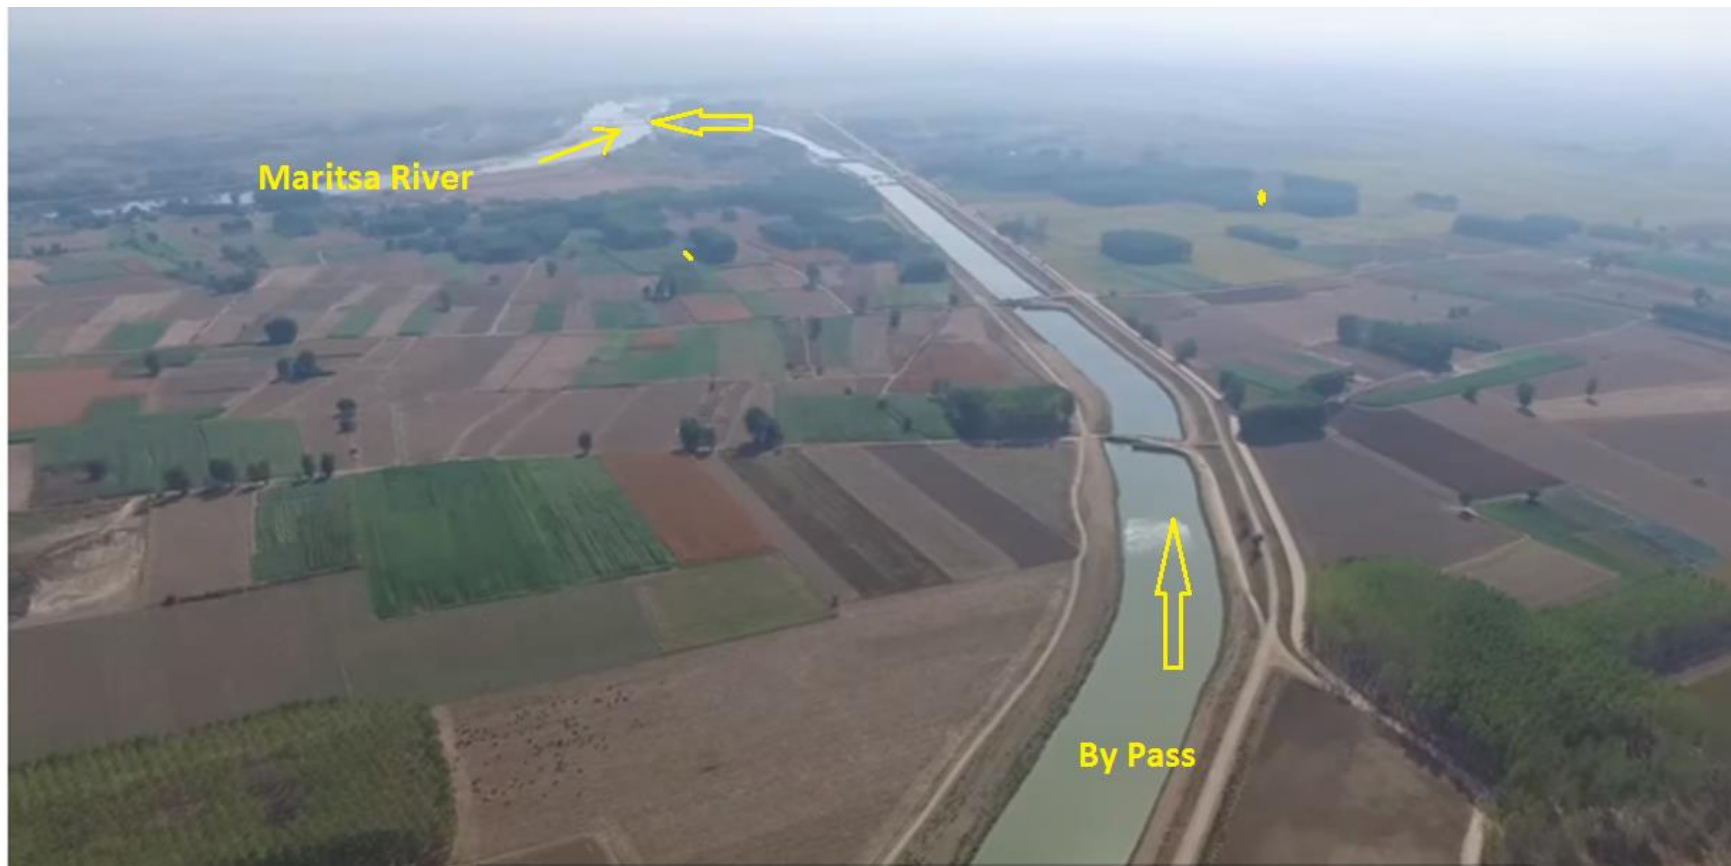
Maritsa River

By Pass

An aerial photograph showing a river bypass channel and a dam. The bypass channel is a straight, narrow waterway that runs parallel to the main river. It is bordered by earthen embankments. The main river, the Maritsa River, is wider and has a more natural, winding course. A dam structure is visible across the river, with water flowing through it. The surrounding landscape is a mix of green fields and brownish soil, suggesting a rural or agricultural area. The sky is clear and blue.

**By Pass
Channell**

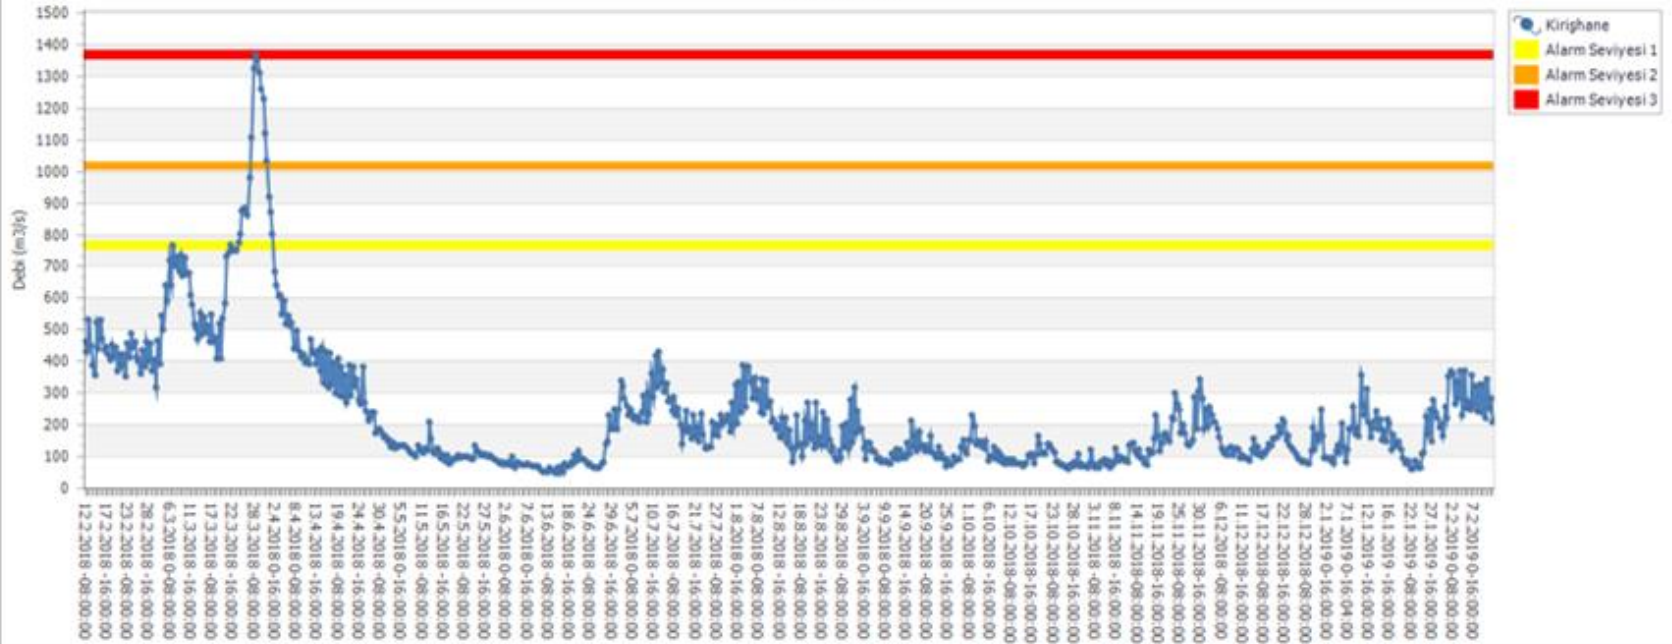
MERİÇ-Kirihane

DSİ 11.BÖLGE MÜDÜRLÜĞÜ NEHİR DEBİLERİ
